Friction and Wear Characteristics of TiC Surface Coatings in a Small Two-Stroke Utility Engine

NG Ka Jun, Farhad B. Bahaideen, Dr. Horizon GITANO-BRIGGS, Dr. Zaidi Mohd. RIPIN
University Science Malaysia

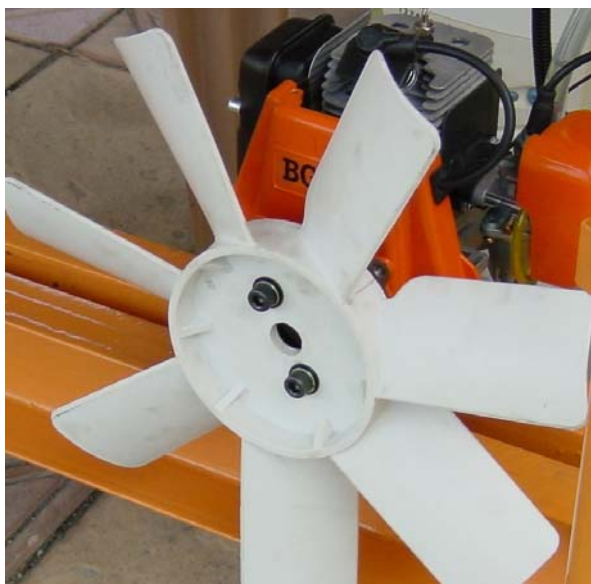
Figure 3 Fan dynamometer coupled to test engine

A new engine was acquired with several spare pistons and ring sets for this study. It was coupled to a fan dynamometer and operated at wide-open throttle (WOT) burning a 25:1 fuel/oil ratio for 5 hours. This initial burn-in was intended to burnish the bore roughness, and reduce its influence in subsequent data. The characteristics of the fan load are shown in figure 2, while the engine and fan are shown in figure 3.

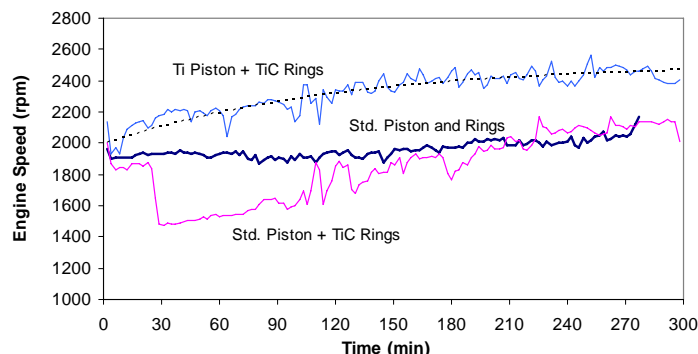
The speed histories of the three runs are shown in figure 4. In each case the engine operates at 2000 rpm \pm 500 rpm. In general the trend is toward higher speeds with time. The nominal combination experiences the smallest increase from 1900 rpm to over 2000 near the end of the run. A relatively small change was expected as only the top ring was replaced for this run. The lower ring, which had previously been present during burn-in of the engine, was left in place to aid in the determination of the wear rate. The increase in operating speed is more obvious with the fresh ring packs of the 2nd and 3rd runs. The standard piston with 2 new TiC rings begins operation at around 1850 rpm, and experiences an unexpected drop in speed to 1500 at approximately 30 minutes. Some scoring of the piston was noted after tear down, and it is believed that this drop in speed is associated with some form of catastrophic wear event. The engine slowly recovers over the course of the next two hours, and finishes the run with a speed of 2150 rpm. The Ti coated piston with a fresh set of TiC rings starts out with a speed of 2050 rpm, and continues up to over 2400 rpm.

Figure 4 Speed histories of the various runs

Apart from the anomaly in the 2nd run (at 30 minutes), the 2nd and 3rd runs have similar curvatures, indicative of a 1st order system response with a time constant of approximately 120 minutes. This response fit to the data of the 3rd run is also seen as the dotted line in figure 4. This shows that in general the time constant for piston-ringing to bore wear on these small engines is approximately two hours. A summary of the initial and final velocities, average power production, fuel consumption, operating cylinder head temperature and overall break thermal efficiency is shown in figure 5.

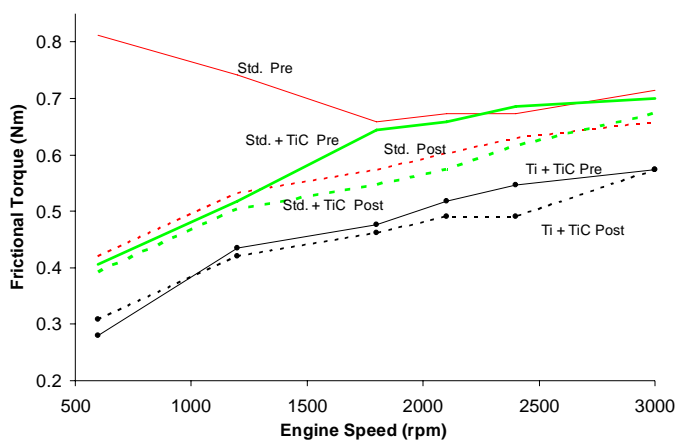
Results of the frictional measurements are shown in figure 6. Several observations can be made from this data. Except for the nominal piston and ring set at low speeds, each combination gives higher friction with engine speed. This is similar to what was measured in previous studies.

Figure 6 Motored engine friction versus speed for the various piston + ring combinations. Post run data is indicated by dotted lines.

The effects of burnishing can clearly be seen in the frictional data in figure 6. For the standard piston with both ring sets the post run data shows an approximate 10% decrease in friction, most noticeable at 1800 rpm and above. A final interesting feature of both the frictional data and the speed data is the apparent effect of frictional coatings. Comparing the post-run data we notice that the TiC coated rings give an average of 3.6% less motored friction than the nominal rings, and the coated piston and ring pack give an average of 20% less friction than the nominal set. While the 3.6% improvement for the coated rings is in the expected range, the 20% reduction for the Ti coated piston and TiC rings was a surprise. Metrology gave insight into all of these issues.

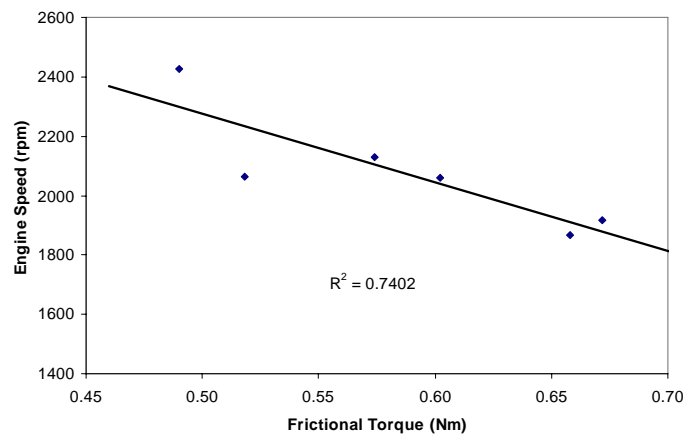
Additionally the correlation between lower friction and higher engine speed can be seen. Taking the friction data at 2100 rpm from figure 6 and plotting it against the corresponding engine speed we get the data of figure 7. The initial engine speed is plotted against the pre-run friction, and the final engine speed is plotted against the post-run friction. Lower engine friction means that more of the indicated power is available as shaft power. This

results in an increase in the operating speed of the fan dynamometer. Taking a best fit line from this we can model the increase in engine power as a function of engine friction. This will also allow us to estimate the possible efficiency improvement achievable through friction reduction.

Figure 7 Engine motored torque (sans carburetor and spark) versus loaded operating speed
